## Land use around Corumbá IV reservoir: analysis and alignment with PACUERA guidelines

Analyzing land use over time is essential for understanding the landscape's geoecological changes, which directly affect vital resources like water and biodiversity. This study investigates changes around the Corumbá IV Reservoir to track landscape modifications and evaluate local planning since the reservoir's establishment. We utilized digital cartographic data from IBGE (municipal boundaries), DGI/INPE (digital terrain model), MapBiomas, and satellite imagery from Google's database, processing all inputs in QGIS 3.34 to create maps that compare observed land use with the strategy outlined in the PACUERA. Results indicate increased lakeshore urbanization between 2016 and 2023, along with reductions in forested and agropastoral areas and non-compliance with the original plan. We conclude that environmental planning needs restructuring.

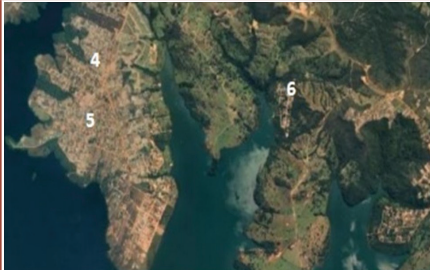
**Table 2** – Divergent classifications under different image resolutions

Accordingly, street-grid areas were manually mapped (Google™ satellite composites for 2023 at 0.5 m resolution) to approximate on-the-ground conditions and identify subdivisions still under development. At MapBiomass's 30 m spatial resolution, street grids and low-density built areas are often absorbed into non-urban classes (here, Agriculture/pasture). As shown by the orange-circled locations (Table 2), several newly forming subdivisions were classified as agricultural/pastoral because of extensive grasses and sparse construction.
